## INVENTORY INSPECTION REPORT

# COLEBROOK LAKE SERVICE BRIDGE COLEBROOK LAKE DAM COLEBROOK, CT

MAY 1995

DEPARTMENT OF THE ARMY  
NEW ENGLAND DIVISION, CORPS OF ENGINEERS  
COLEBROOK RIVER SERVICE BRIDGE  
INVENTORY INSPECTION

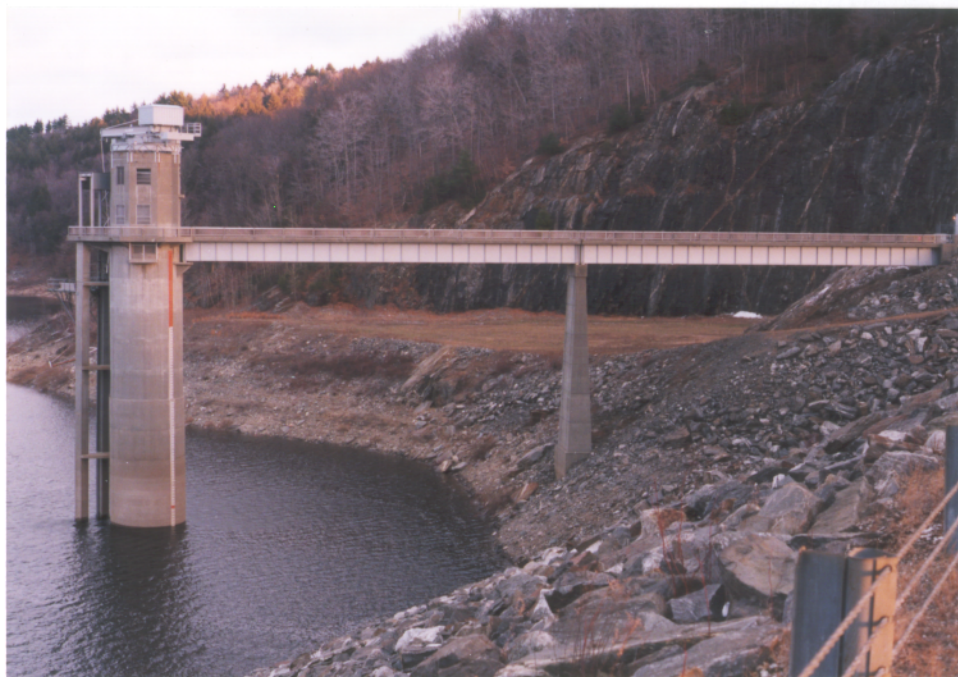
①

DESCRIPTION: SOUTH ELEVATION OF BRIDGE.

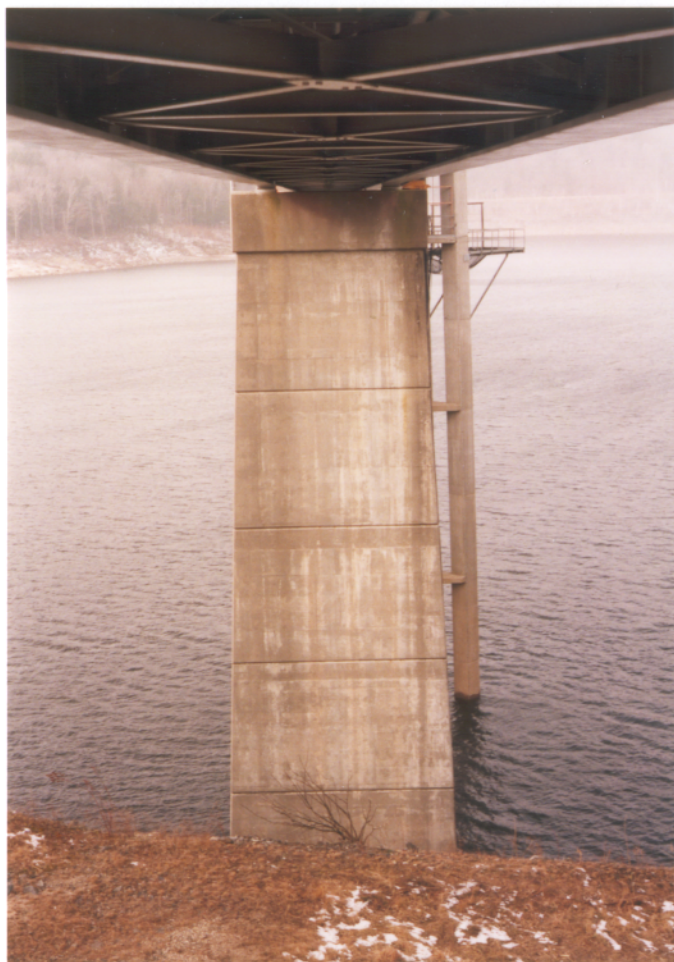
③

- The pier exhibited 3 spalls, the largest being 4" long by 4" wide by up to 4" deep corner spall on the base.
- A 15" diameter delamination was noted near the base of the pier of the east face.
- Rust stains were observed near top of the pier.

DESCRIPTION: EAST ELEVATION OF PIER.

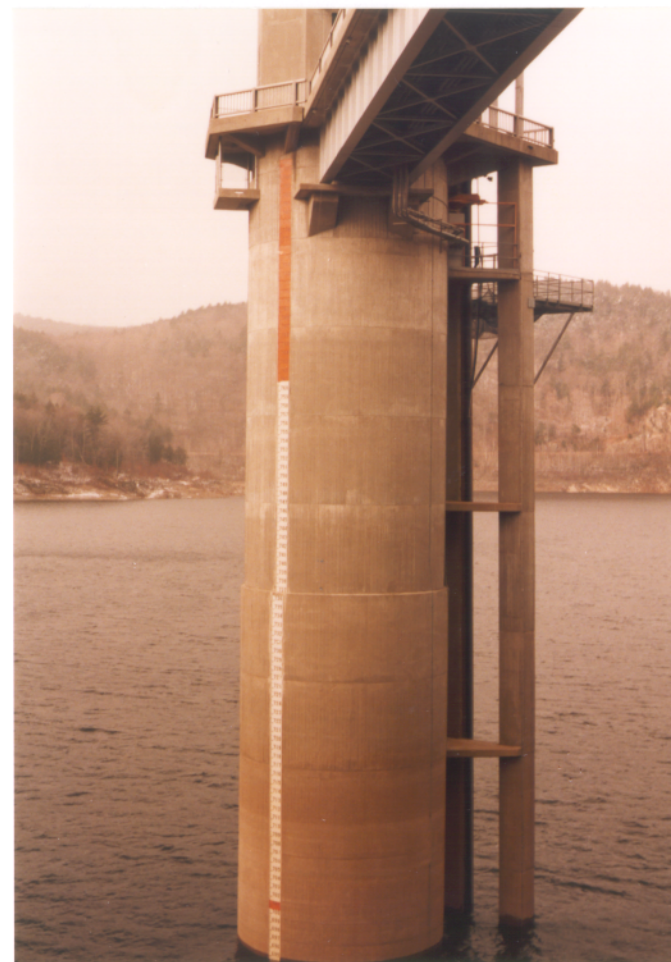
④

The Intake Control Tower was generally in good condition (see Report Photo 4) with isolated locations of exposed reinforcing on the walkway surrounding the tower (see Report Photo 5).

DESCRIPTION: EAST ELEVATION OF INTAKE CONTROL TOWER.

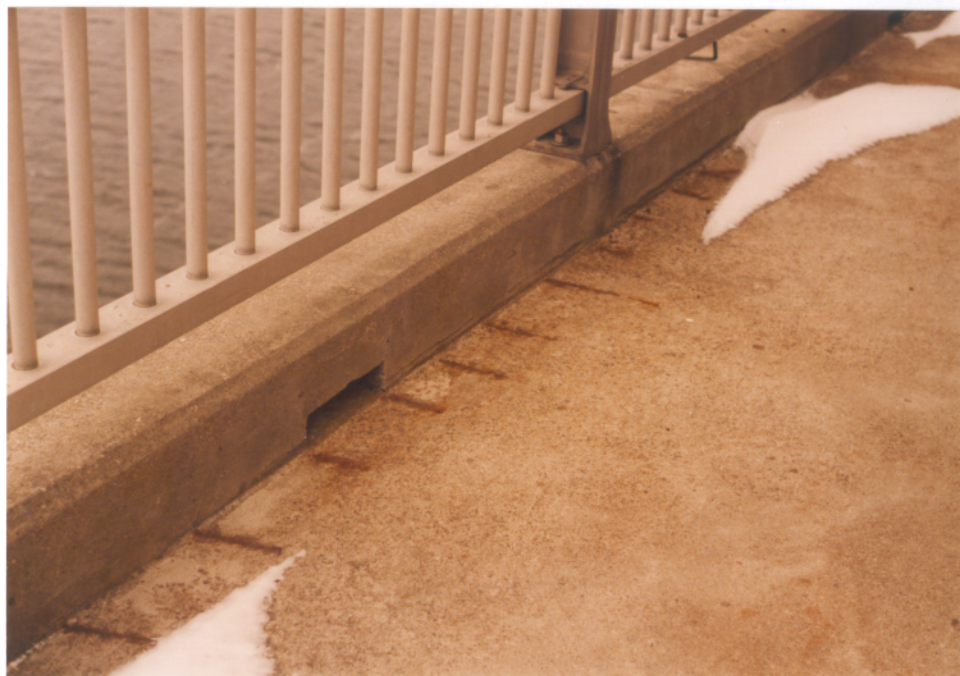
5

DESCRIPTION: EXPOSED REINFORCING ON WALKWAY SURROUNDING THE  
INTAKE CONTROL TOWER.

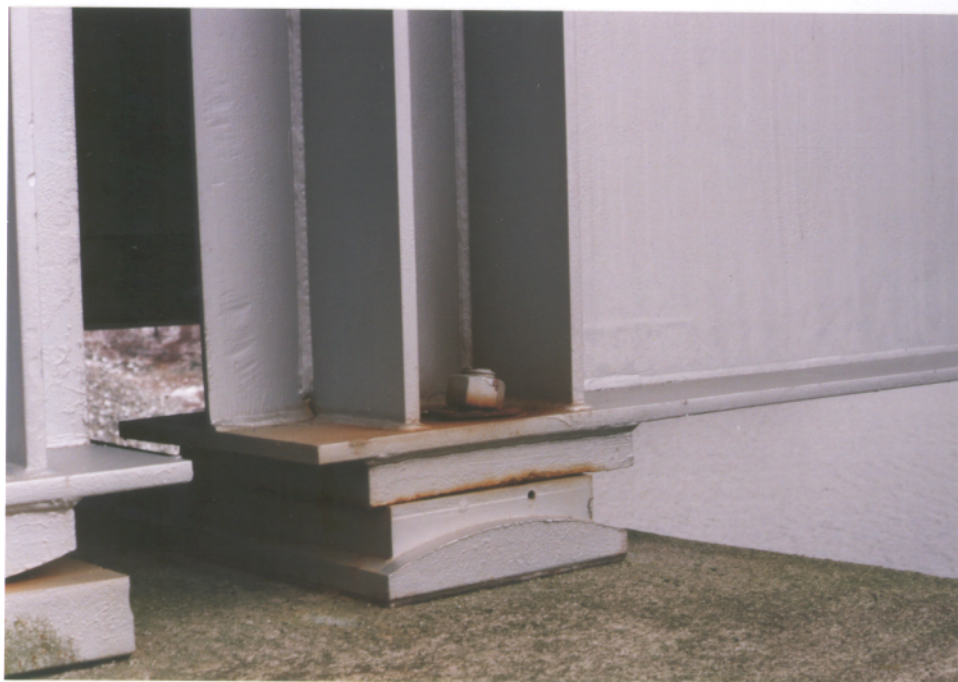
7

- The expansion bearing anchor bolts were bent at the south expansion bearing at the abutment (1 out of 2), the south expansion bearing at the pier (2 out of 2), and the north expansion bearing at the pier (1 out of 2) (see Report Photo 7).
- A gap was observed between the anchor bolt nuts and the anchor bolts on the north fixed bearing at the pier (1 out of 2), the north expansion bearing at the pier (1 out of 2), and the north fixed bearing at the Intake Control Tower (1 out of 2) where the nut was found to be loose (see Report Photo 8).

DESCRIPTION: NORTH ELEVATION OF NORTH EXPANSION BEARING ON PIER. NOTE BENT ANCHOR BOLT.

1. The anchor bolts at the expansion bearings (4 locations) appear to be "bent" toward the contracted position. Based upon our observation, an investigation should be performed to determine the cause of this condition and whether or not the "bent" anchor bolts should be replaced. Our cost estimate is based on replacement of these anchor bolts which would require jacking the existing structure.

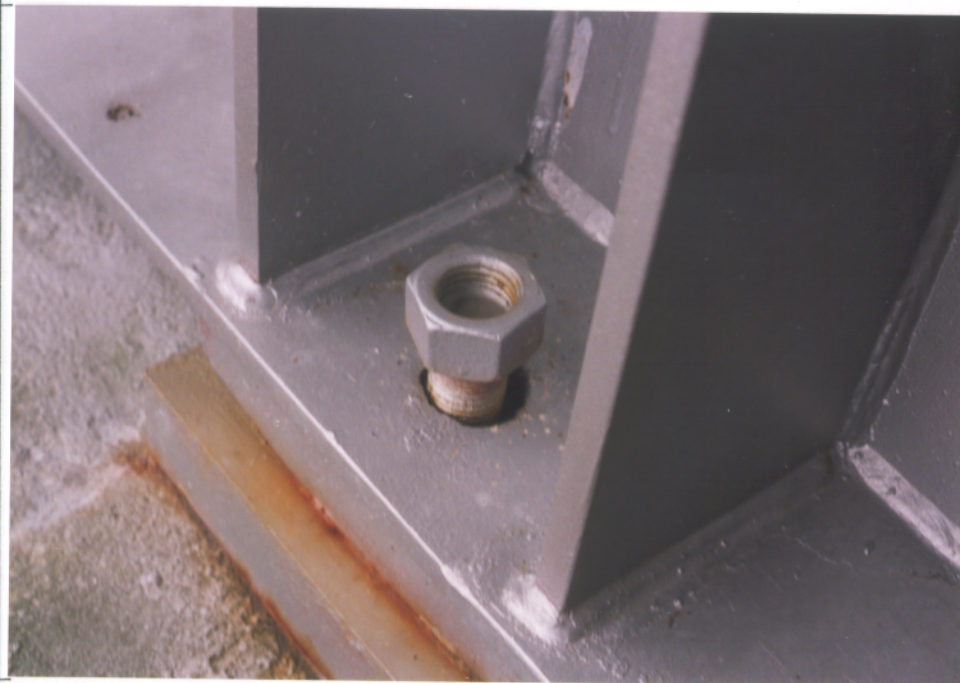
8

DESCRIPTION: NORTH ELEVATION OF NORTH FIXED BEARING ON INTAKE CONTROL TOWER. NOTE GAP BETWEEN ANCHOR BOLT NUT AND ANCHOR BOLT.

2. The anchor bolt nuts at the fixed bearings (2 locations) should be tightened. The nut at the expansion bearing anchor bolt (1 location) should be secured.

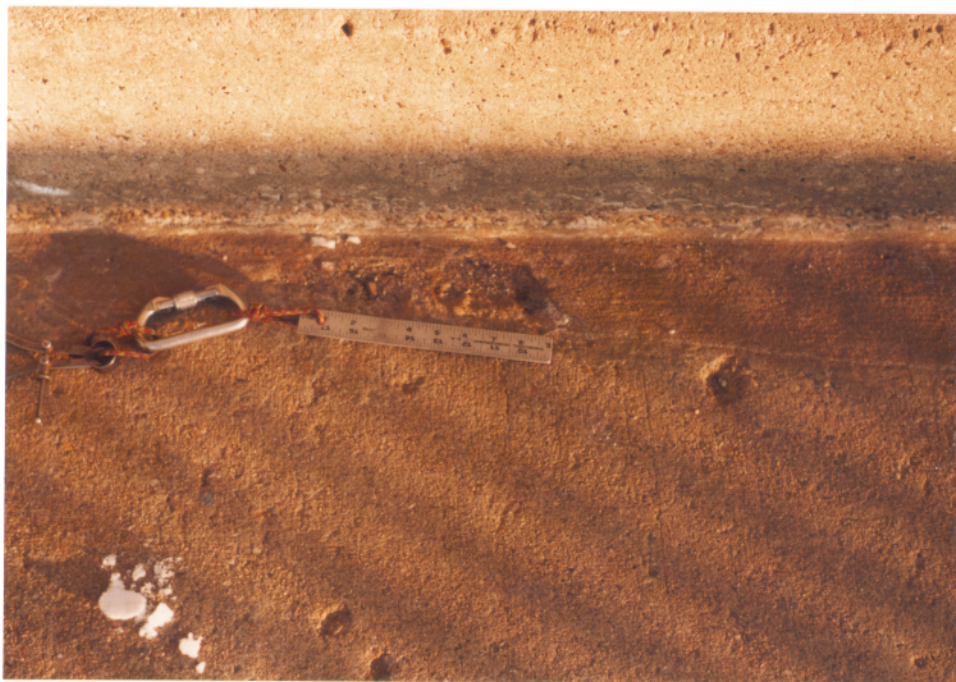
(11)

- A spall 9" long x 2" wide x up to 1/8" deep was noted at the north curbline (see Report Photo 11).
- Numerous hairline cracks were observed on the deck and curbs, the longest being 10'.

DESCRIPTION: MINOR SPALL IN CONCRETE DECK AT NORTH CURB LINE.

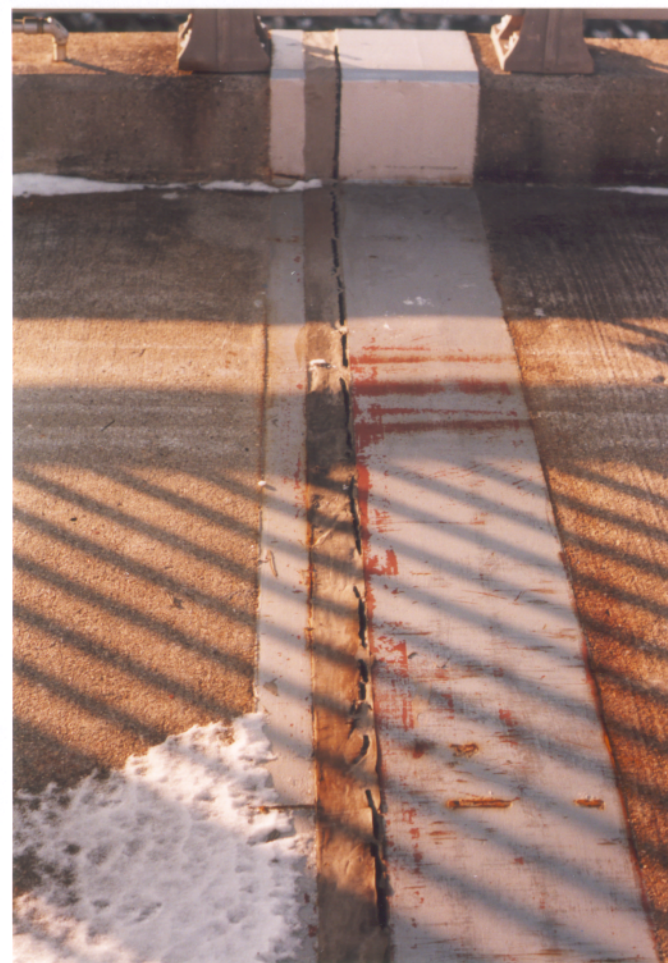
(12)

The expansion joints were generally in satisfactory condition with the joint sealer partially separated from the expansion plates at both expansion joints (see Report Photo 12).

DESCRIPTION: EXPANSION JOINT AT PIER LOOKING SOUTH. NOTE JOINT SEALER PARTIALLY SEPARATED FROM EXPANSION PLATES.

4. The joint sealer at both expansion joints is partially separated from the expansion plates apparently due to the normal expansion and contraction of the joints. The joint sealer should be removed and replaced with new joint sealer to prevent water runoff through the joint.

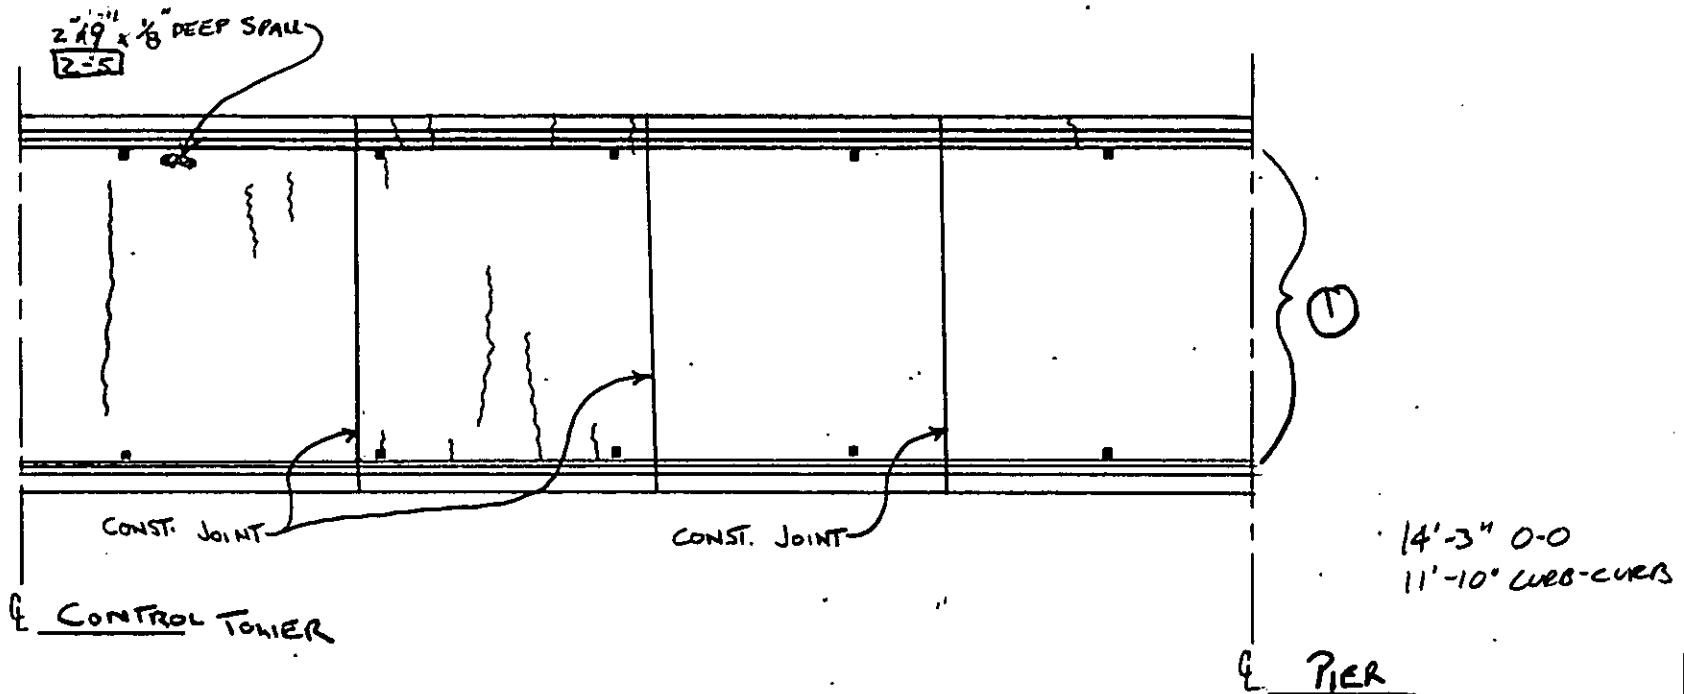
① SEAL AT JOINT BEGINNING TO FAIL,  
MEMBRANE PULLING AWAY FROM STEEL [2-6]

NOTE: SEVERAL LIGHT SURFACE SCRAPS ON DECK, APPARENTLY FROM SNOW PLOW

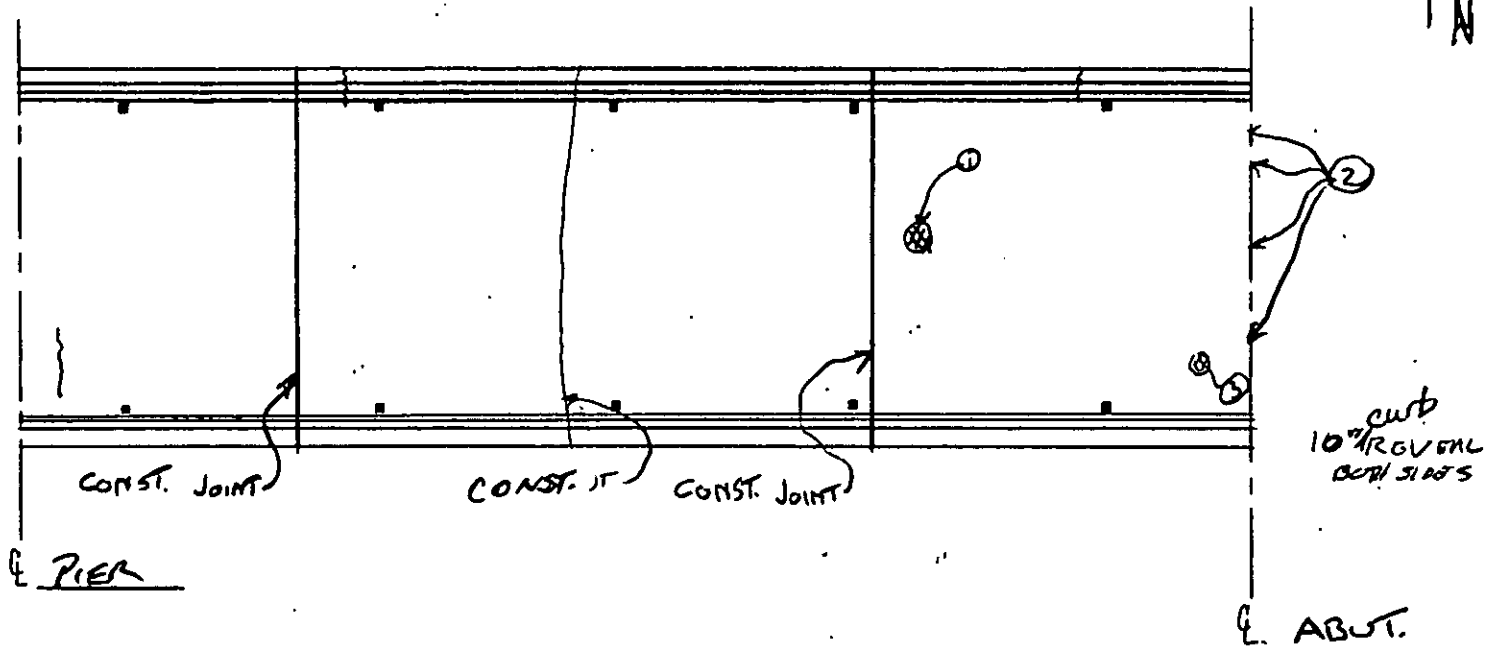
NOTES: ① 1 1/2" Ø x 3/16" DEEP SPALL

② UP TO 3" LONG SECTIONS OF JOINT SEAL PULLING AWAY FROM

STEEL 2-8,9

③ 2" x 1" x 1/4" DEEP SPALL

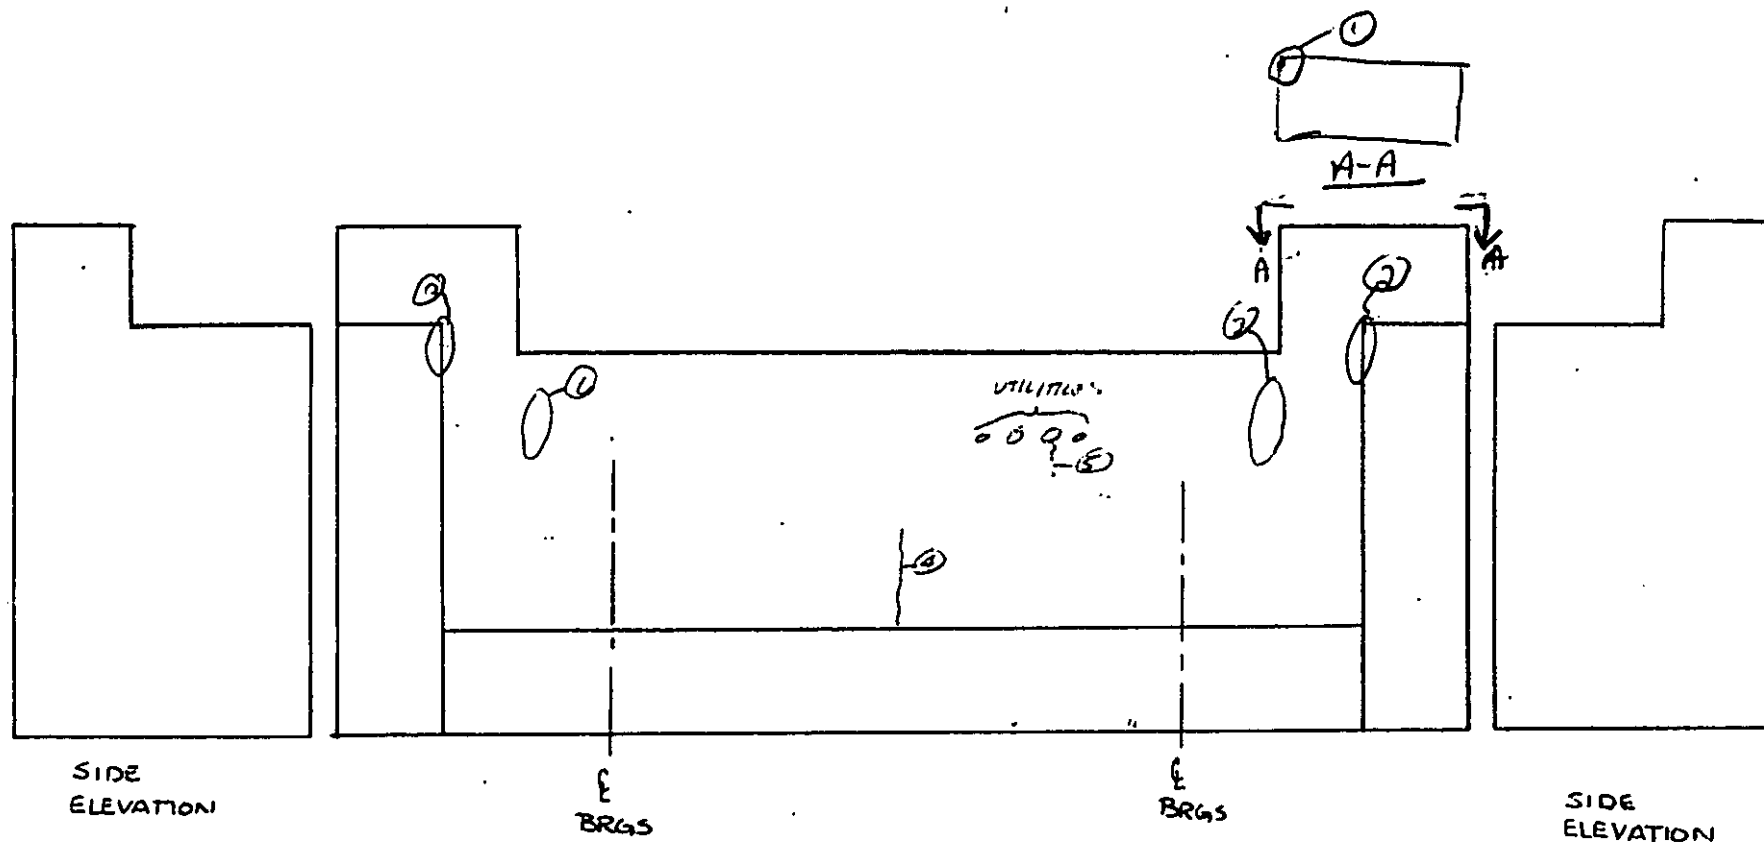
NOTES: (1) SPALL ON ENDOPOST 9" x 4" x 3/8" HIT ? [2-10]

(2) JOINT FILLER MISSING - FALLING OUT

(3) STAINS ON BACKWALL FROM WATER THROUGH JOINT

(4) HAIRLINE CRACK 2' LONG

(5) FROM UTILITY SLOTTED 10" LONG

(6) ICB ON BACKWALL (NORTH SIDE) [2-14]

3. The joint seal between the breastwall and backwall is partially missing and should be replaced with new joint filler to prevent water runoff onto the abutment seat.

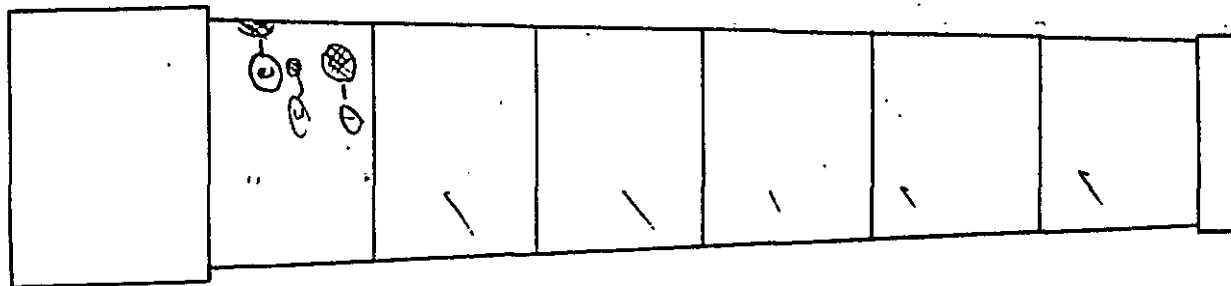
NOTES: ① 15"  $\phi$  HOLLOW [5-15]

② 4" X 3" X 1" DEEP SPALL

③ 4" X 1/2" DEEP SPALL

WATER STAINING AT TOP OF PIER

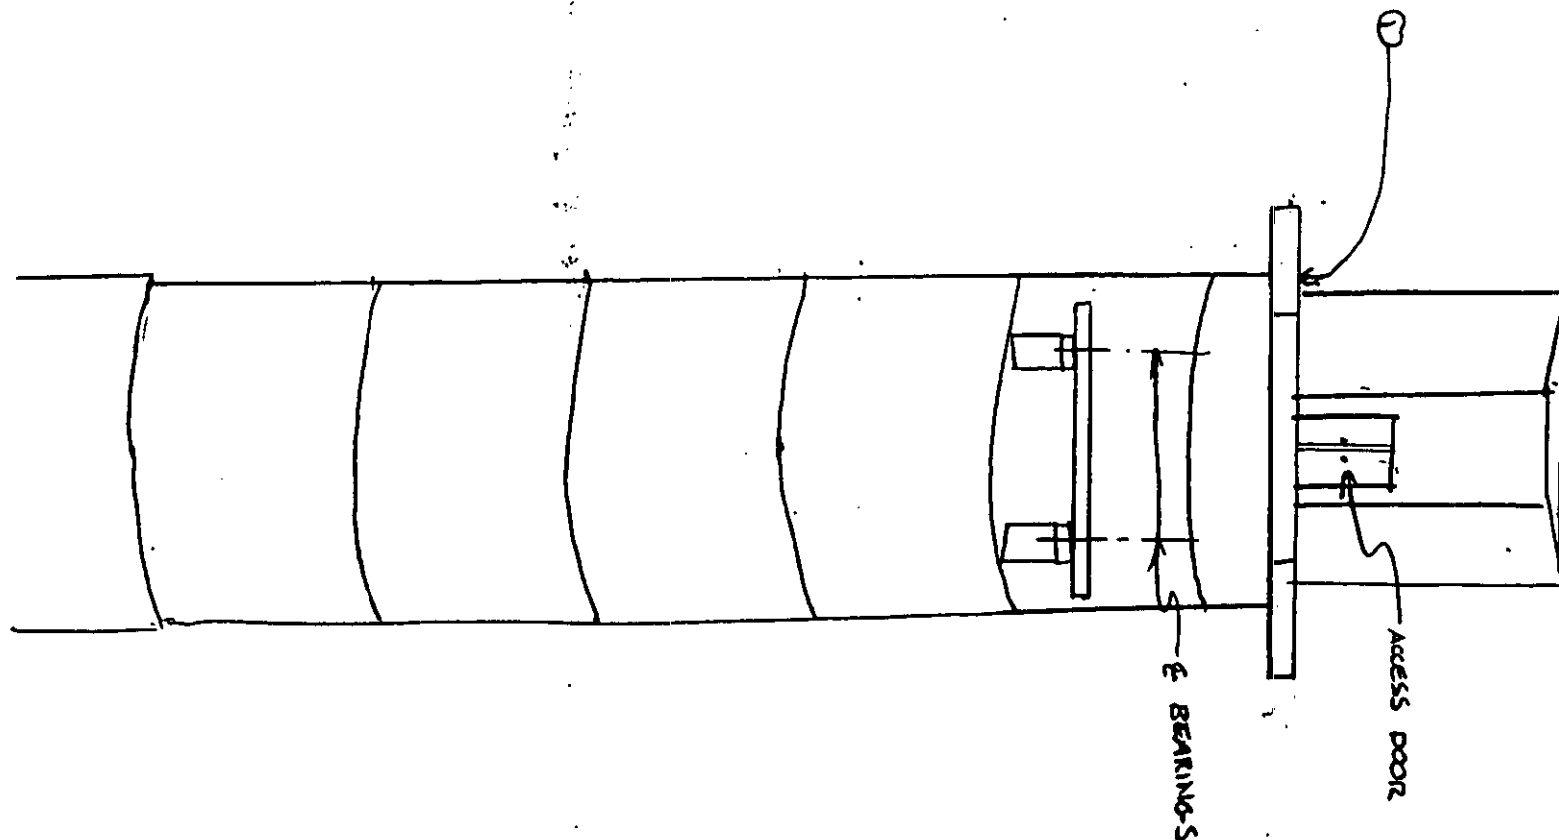
INTAKE CONTROL  
TOWER

NOTES: ① EXPOSED REINF — NO COVER ON <sup>Top of</sup> SOUTH SIDE WALKWAY  
DECK SLAB 2-20

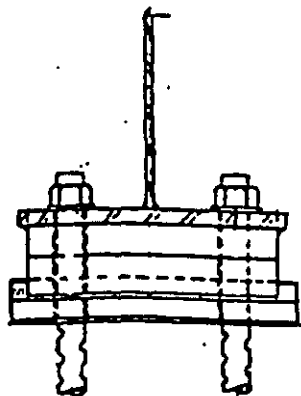
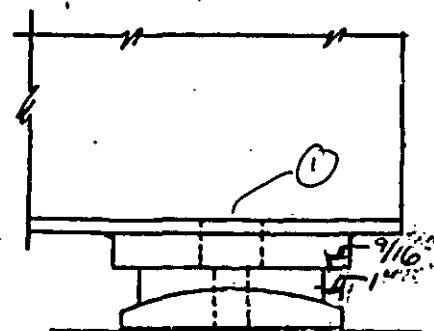
SOUTH EXPANSION BEARING @ ABUTMENT

NOTES: ① BENT BOLT (Bent west) (S. Anchor Bolt) OUTSIDE OF SOUTH GIRDER AT ABUTMENT [2-13]  
 DIMENSIONS ON EAST SIDE

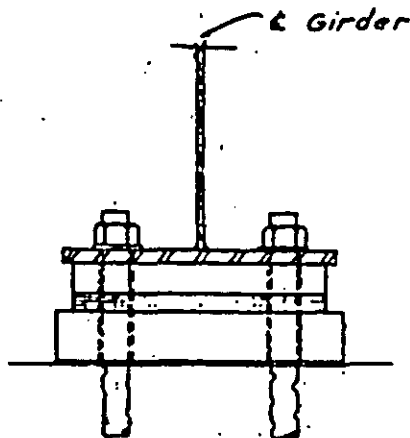
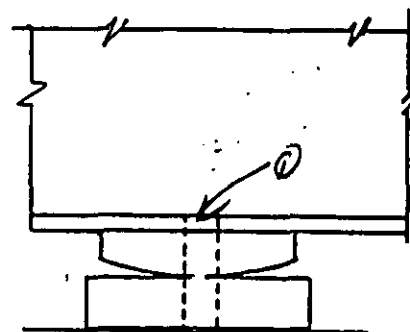
NORTH FIXED BEARING @ PIER

① North anchor bolt nut unthreaded to top of bolt

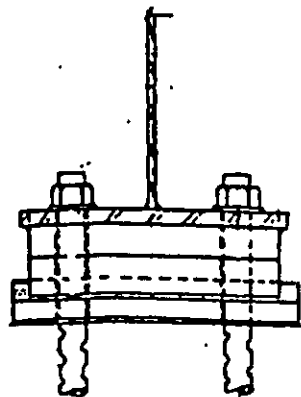
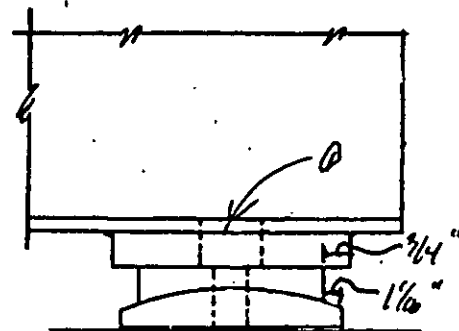
SOUTH EXPANSION BEARING @ PIER

① North-South Anchor Bolt slightly bent west

Signs of movement not apparent, paint sealed.

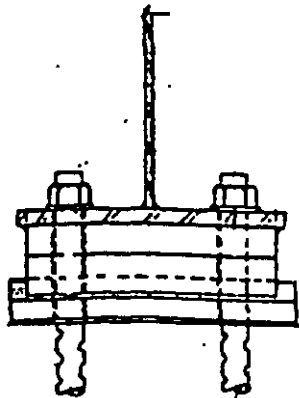
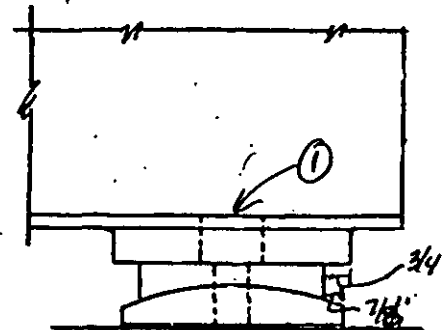
NORTH EXPANSION BEARING @ PIER

① North Anchor bolt bent <sup>11-14</sup> West, South anchor bolt nut not threaded all the way down.

Signs of movement not apparent (paint sealed)

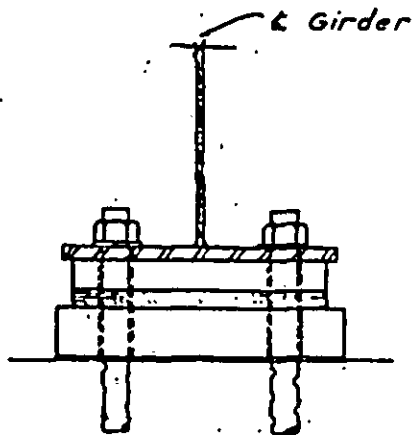
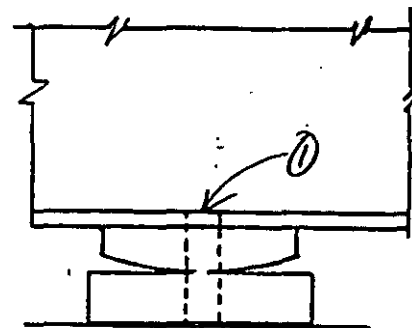
NORTH FIXED BEARING @ CONTROL TOWER

① North Anchor Bolt not loose and almost threaded off [1-20]
